MY PROJECT DETAILS

Project: Park Lane Retirement Village

Park Lane Project

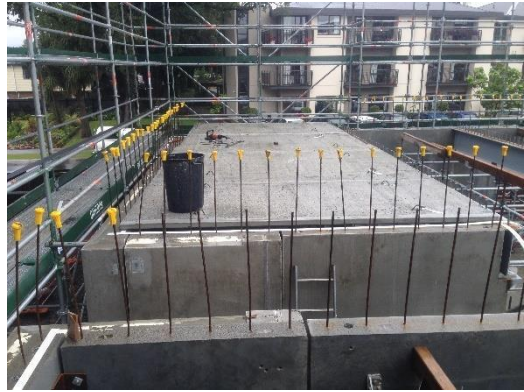
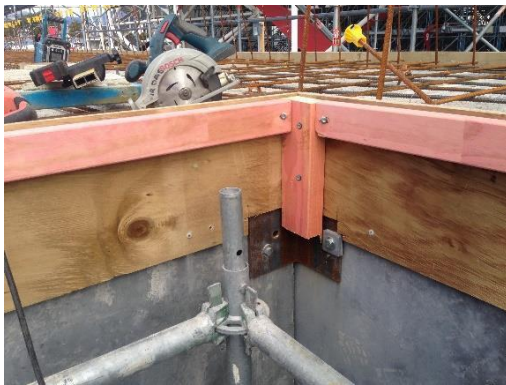
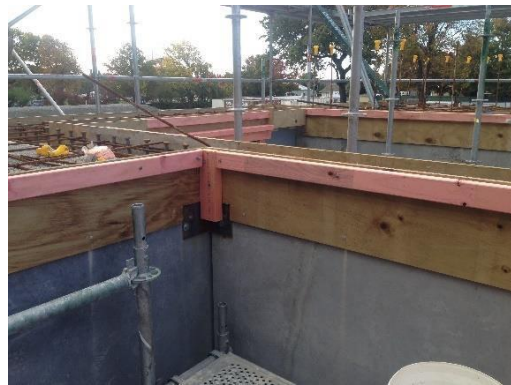
After the flat slabs had been installed we moved onto boxing around the edge formwork of the first floor. This had to be done in two separate pours as the area was too large to be done in one, this allowed us to minimise wasted boxing by reusing the first set. The floor would be 150mm thick as per the engineer's specifications. We were unable to fix the boxing to the face of the panels as they would be finished and visible, to overcome this obstacle we used a series of 40mm by 40mm aluminium angles that were fixed to the top of the panels, then the ply was connected to the angle to hold it in place. We then tied the ply off to the reinforcing to keep it plum. Twelve penetrations were boxed into in the concrete for where the steel beams would connect with the sub floor mountings. After completing all our checks, we were ready to pour the first 60m3 concrete section, the subsequent section used mainly the same method and the work was carried out without a problem.

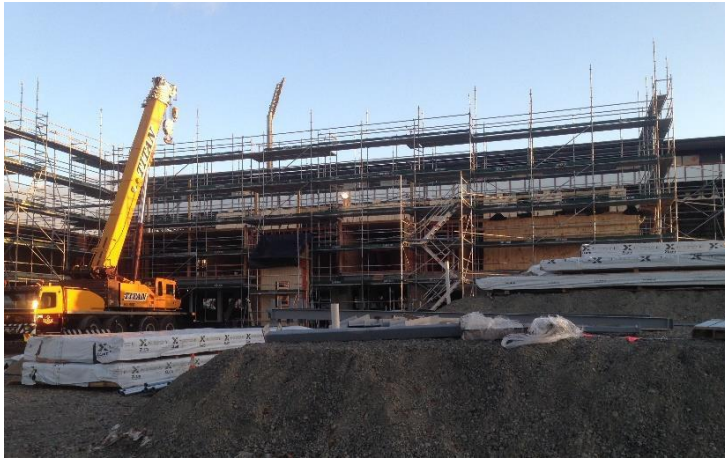
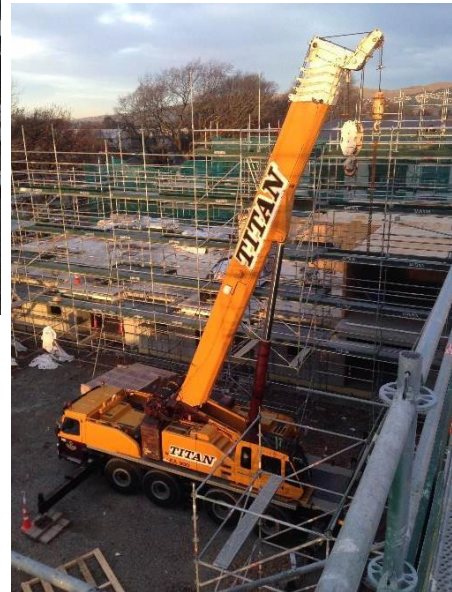
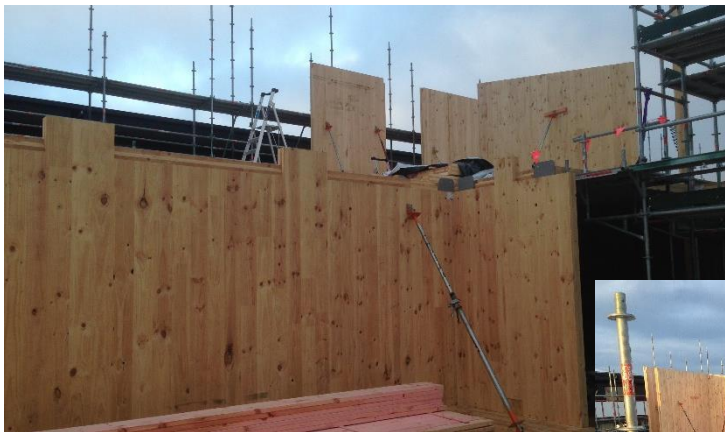
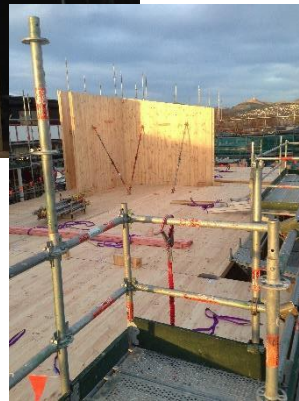
Here are a few picture of how the building looked during the time of construction, unfortunately most of the surfaces have been covered up in the final design.

The next part of the job was to assemble the CLT panels. AW took a back seat to this while our certified subcontractor lifted and placed most of the wall panels and walls. It was very exciting to see such a large amount of timber being used on a commercial job, it was something I was not used to. Although this was a subcontracted job, I was able to jump in and help here and there. One of the more interesting parts of assembling the structure was the different ways in which anchors were used to connect adjacent panels. One of the methods that was applied to this build, as shown in the detail on the right, is the use of a large steel tongue penetrating through both panels, this together with 18mm folded-steel rods housed into twelve 18mm holes created enough compression to hold the panel in place. This process was drawn out due to unforeseen supply issues, it took over 3 months for all the panels to be delivered.

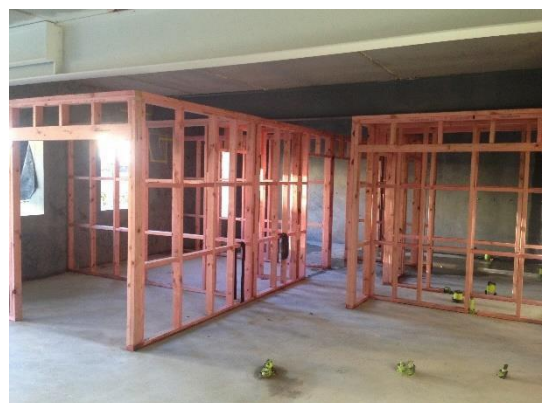
We began standing the Placemakers frames to make sure they were straight, plum, and square, bracing as we went. All the internal walls are constructed out of 90x45 H1.3 SG8, 2.4 stud with

600mm centre and in contrast to that all the exterior walls are 140x45 H1.3 SG8, 600 centres made to fit the cavities

While the CLT was going up around us we also started the mammoth task of framing up the partition walls and windows. We received a delivery from the Placemakers frame yard consisting of the whole ground and first floor frames. We instantly got to work setting out, the transference of the grid lines to the pad was very important as that is what we would later use to set out all the frames from. Due to this being a high-spec building designed to have disabled and wheel chair access, it was critical that the measurements were spot on. Had we been under then there would have been problems gaining our code of compliance.

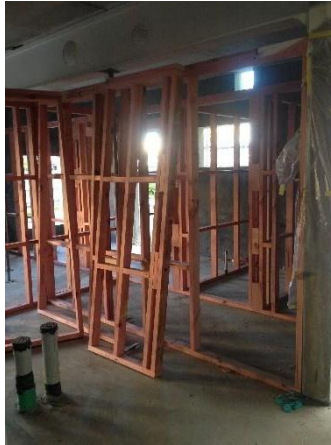
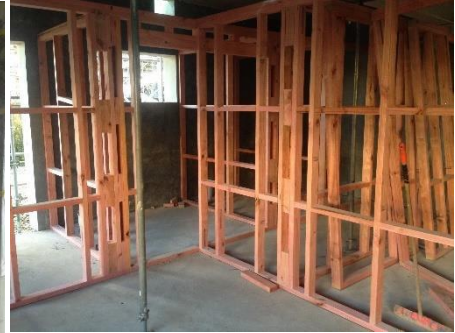
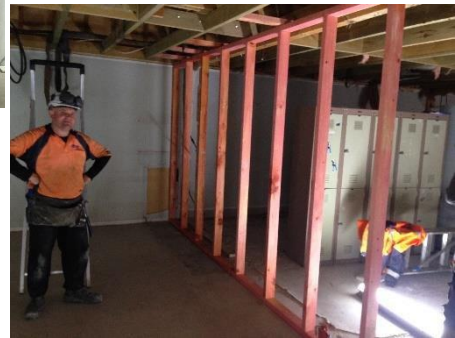
Some frames needed to be constructed on site. We marked out where the walls were to go then got to work cutting.

Assembling the frames wasn't too difficult and we were able to store them against the installed walls. To fix the frames together we used a 75mm ramset spitfire which allowed us to shoot down the frames, then came back later with a 12mm hold down bolt.

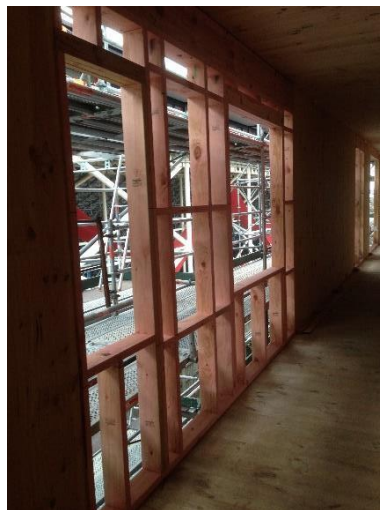
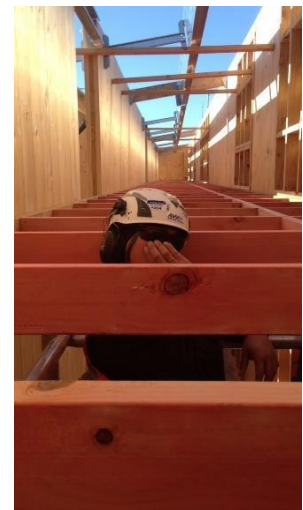
The exterior walls were constructed in-between the CLT installation, filling the cavity, and framing out for the windows. The frames were made up of 140x45 H1.3 SG8, 600mm centres and made to fit, they were stepped back 7mm from the CLT edge so that once the 7mm eco ply was attached, it would be flush with the exterior wall. We used 100mm teck screws to fix the 140x90 to the timber floor and timber sides, this was so if we needed to, we could move the wall. The exterior was clad with 7mm eco ply treated to H3.2 making sure the panted edge was always to the top. It was screwed down with 55mm stainless wood crews every 150mm centres around the edges and 300mm through the middle, I created a story rod to make it easier to make

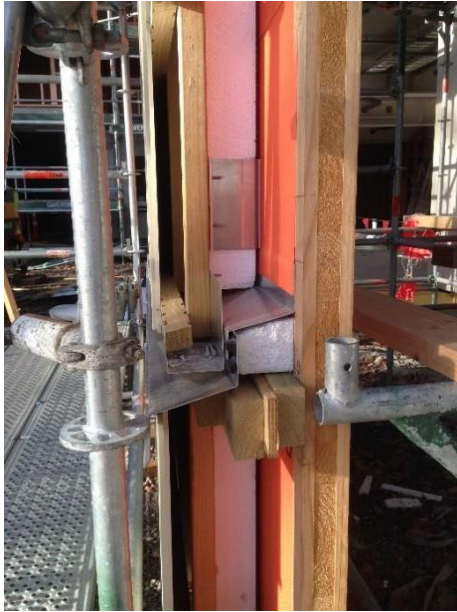
This drawing detail shows the interstory flashing

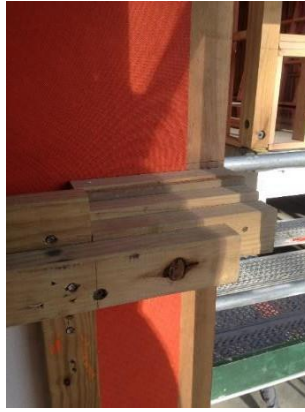
This picture shows the interstory flashing system along with the solid blocking for fire resistance

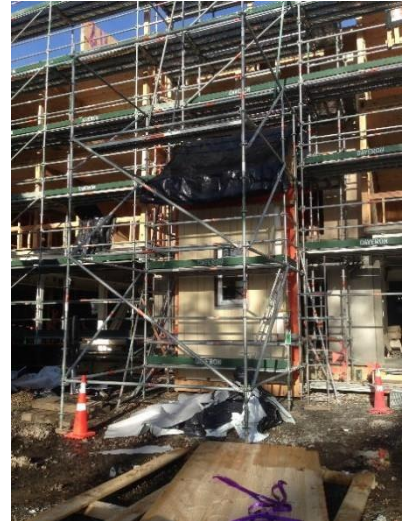
The interstory timber fire break

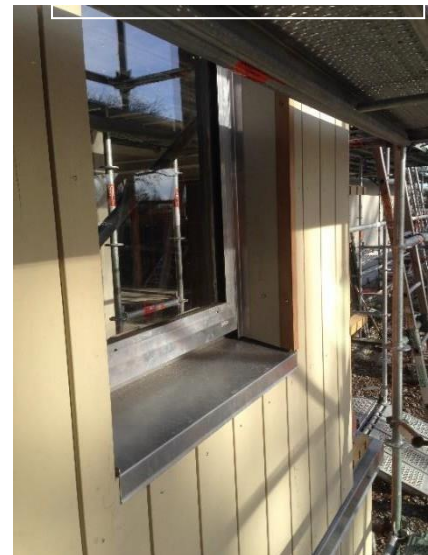
Here is the overall look of the test panel, the application will be replicated onto the building in a few weeks

The window sits back from the front of the cladding, as you can see there is a capping installed on the corner then a returned piece of Accoya, all fitting around a sill flashing.

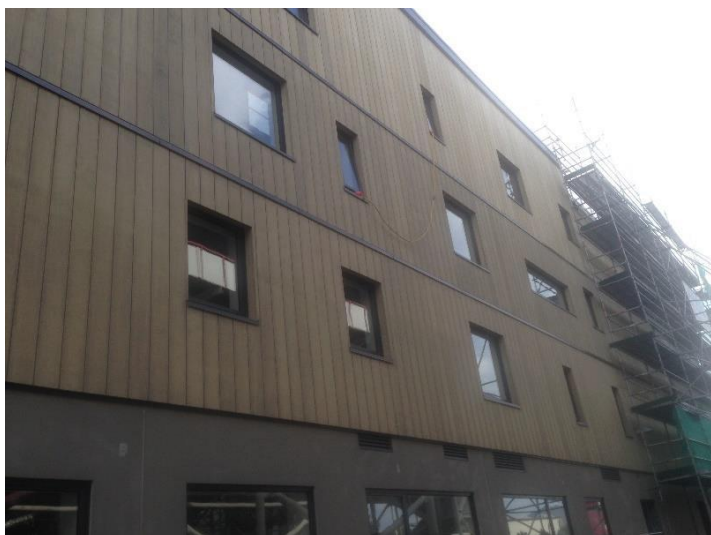
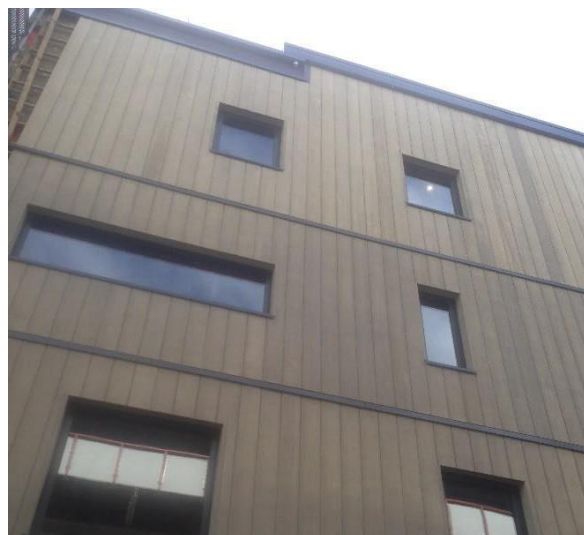
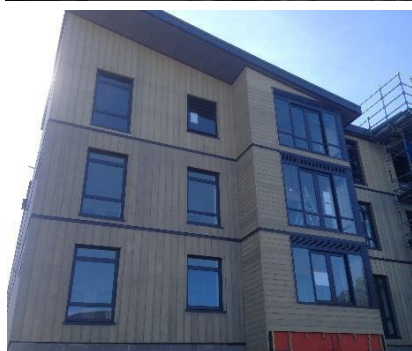
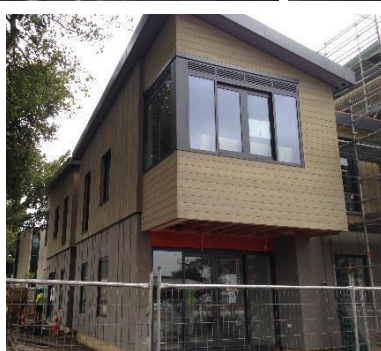
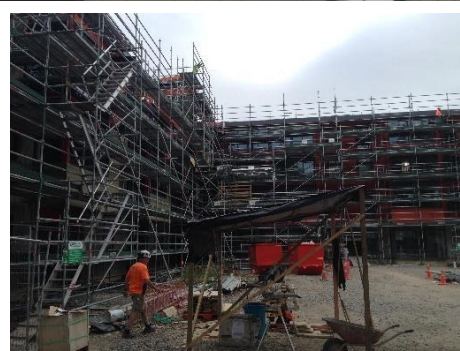
This set of pictures show how the cladding came together, starting from the back and working our way around to the front, this was a massive job and really tested my skills as a carpenter, but I think it was a very valuable experience considering it's a cladding system that is not yet common in New Zealand.

Starting on the first level over on the back wall we began the massive job of cladding. Each floor was roughly 50m long making this part of the job very material heavy. At the beginning we started with setting out for the three stories then continuing with the 600 centres and expanding from there with the 900 vertical measurements. After that stage was over we replicated the same building techniques as on the test panel, the Z brackets were installed the ROXUL was placed and the 70x45 could be installed over that. Following the castellated batten, we were able to start cladding, we lasered in a line at 1060 onto the batten then marked every board the same, this was so we could keep a straight line on the bottom of our boards. Every morning we would cut around 30 boards and fit them in a day, making sure to pull lines every 480mm on the boards and nailing them off. When it came to the windows we would have to cut our boards individually to suit, taking 25 mm plus the length of where the board landed, this was so we could add the corner moulding onto the sides once the sills were installed. This was a very lengthy process, taking around eight months to complete the building.
