**Project: 19 Kingsley Street, Westmere.
March 2023 - September 2023**

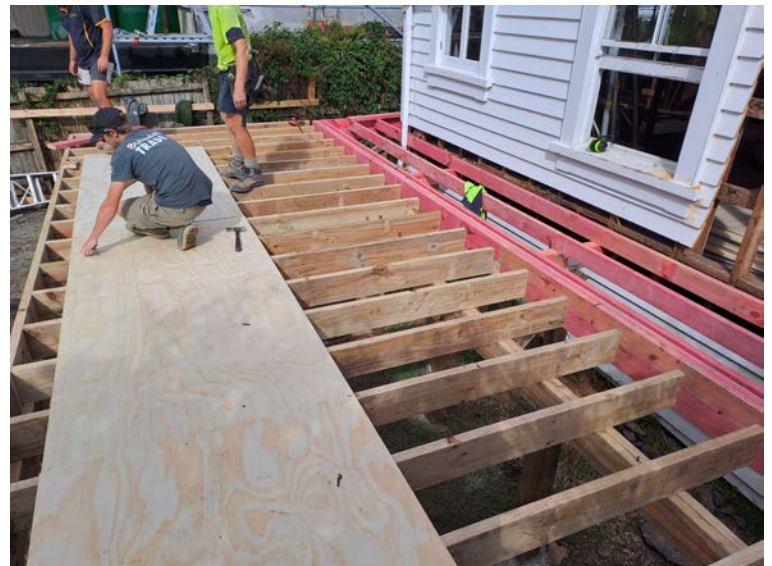
There were 19 brace piles, one anchor pile requiring 12kN pile fixing kits, and the brace piles needing the braces installed following the NZS3604 detail, Figure 6.6 (Brace Connected to Pile).

All the remaining ordinary piles had two SS wire dog bearer-to-post connections and 2xM12 SS 250mm engineer bolts connecting the pergola post to the bearer and joist. Five 400x400x600mm holes with 125x125mm H5 posts were added under the existing structure to take new point loads. Temporary plywood was used to make a safe work platform until the Matai flooring could take place.

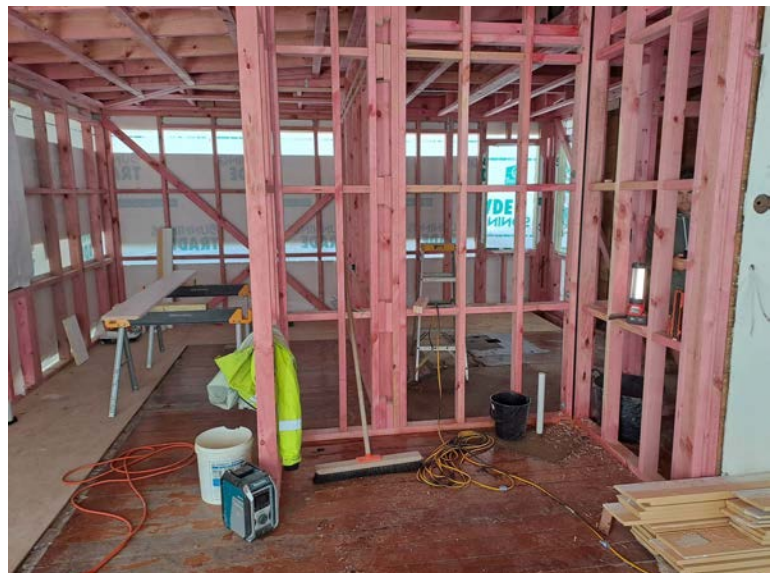
The internal linings from the existing house had been removed to allow for new insulation and plasterboard. The walls originally had scrim and matching, meaning some had to be removed for the new insulation in the wall cavity. Four 200mm matching boards were removed on every external wall to allow sufficient room for the insulation to be installed. There was no need to spend hours straightening walls, and the new plasterboard could be fixed straight over, saving time and materials.

The engineers wanted some new bracing elements in the older areas. The new plans included four EP1 braces and some GS1s and GS2s. Due to the lack of bottom plates in the old framing, we followed a detail in the GIB site guide that the engineer provided to connect the top and bottom plate nogs with a GIBFix angle. The plans specified 12mm plywood for the EP1s, which meant packing the studs 7mm after the 19mm matching had been removed to fit the brace. I suggested using 19mm structural plywood to eliminate the extra packing and using nails three times the sheet thickness as per specifications. The engineer was happy to proceed this way. Nogs at 800mm centres were also added to stiffen and support the existing Rimu studs.

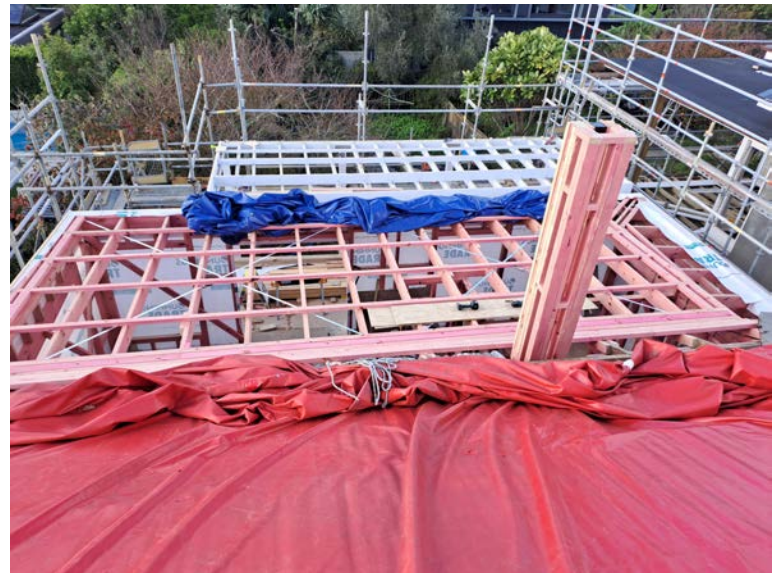
As the supporting structures were in, the roof framing was able to begin. The 5-degree skillion roof was framed with 190x45mm H1.2 SG8 timber. I precut all the roof rafters after finding the seat and plumb cuts. The rafters at 600mm centres were installed with two skew nails and two wire dogs into the double top plate to provide the required Kn rating for the wind zone. I also formed the hip rafter and the returning smaller lean-to-roof rafters. Solid blocking nogs were nailed at the end of the rafters on top of the top plate, and all the extra required fixing for the roof, including the roof strap brace.

I marked out and fixed all the purlins following the roofer's details and the roofing material specifications with one blue screw per rafter following the MiTek guide.

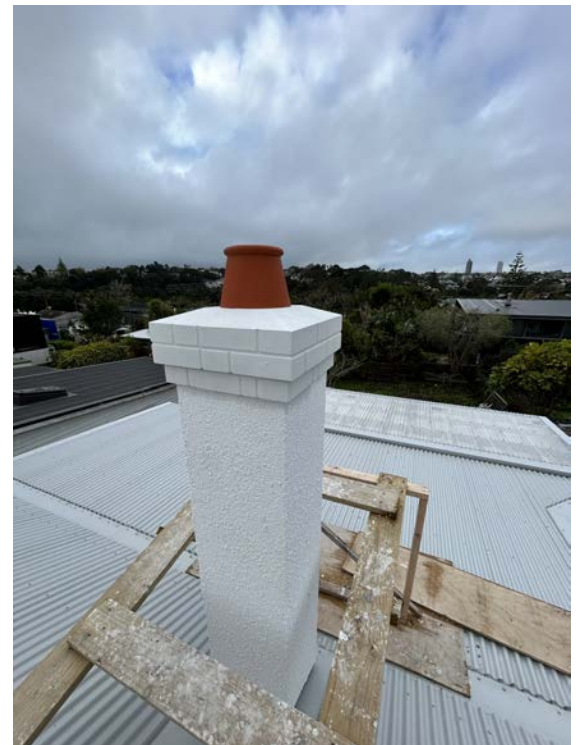
The details specified a 360mm square frame built from 140mm and 90x45mm H1.2 timber bolted to the 100x9 mm SHS steel post at 400mm centres protruding from the roof. The frame was lined with plywood and Thermakraft Watergate underlay. As the original chimney was plastered, a StoStucco Render System was used over the Lath. An Accumen shape terraced brick chimney top with a pot above was produced off-site to finish the replica chimney.

Since the house is protected under the Heritage Act 2014, and the existing chimney needed to be removed to create space within the home, a replica chimney was needed to take its place. This delayed our resource consent from the Auckland Council by a couple of weeks as they verified that the chimney's design would achieve the Heritage Acts' purpose.

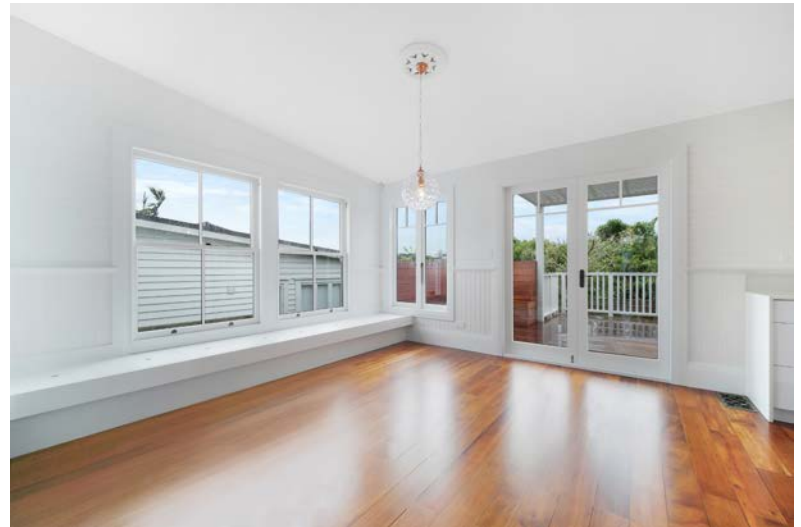
After the post-line inspection, we installed tongue and groove linings in the kitchen/dining area as they were over the bracing element walls. We had salvaged many of the existing boards by carefully prying them off the wall without splitting the tongue or face during the demolition, as we knew the client wanted to reuse them for a few feature walls. The 150mm TG&V boards were glued and nailed to the nogs vertically up to the splashback height above the kitchen bench, then ran horizontally to the ceiling, separated by a dado. I measured the required new scotia, skirting, architrave, dado and picture rails for the job. I also had to provide our QS with a profile drawing of the existing lines to try and match as best as possible. Once the new flooring was installed, we could finish the remaining skirting and architraves, along with the old rimu finishing lines (which were salvaged earlier), to be reinstated.

The rimu lines had to be carefully pry-barred without damage as they were original from when the house was first built. Some had to be installed before the plasterboard to match the existing detail where the GIB was met flush with the bottom of the scotia or top of the skirting, finished with an arch bead, and GIB stopped. The plasterboard was finished in specific areas like this because this detail was in the existing archway, and the client wanted to keep it the same. Also, the existing jamb thickness was to suit the original scrim and wallpaper, so we would have had to replace the jambs on doors and windows to allow for GIB.

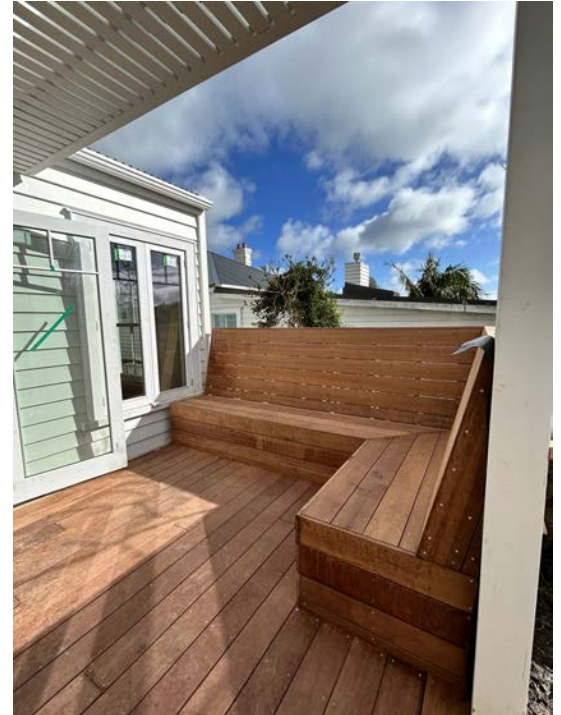
I framed the bench seat on one side of the deck. This required me to study the plans and details, follow the MiTek guide and F4 Safety from Falling. Complying with Figure 6 of F4, the seat could be at most 500mm, and the back rest must be at least 760mm when the fall is over a metre, and it must provide climbing difficulty for a small child. Structural posts were bolted to the deck joists with studs between them as decking would run down the outside. I then figured out the ripping for which the backrest would be most comfortable while creating the best layout for the 140x18mm Kwila decking boards and complying with the building code. The kwila decking would line the entire bench seat frame and backrest with 10G x 63mm 304 SS screws. The decking boards would also cover the 9x3m deck and the exterior stairs.

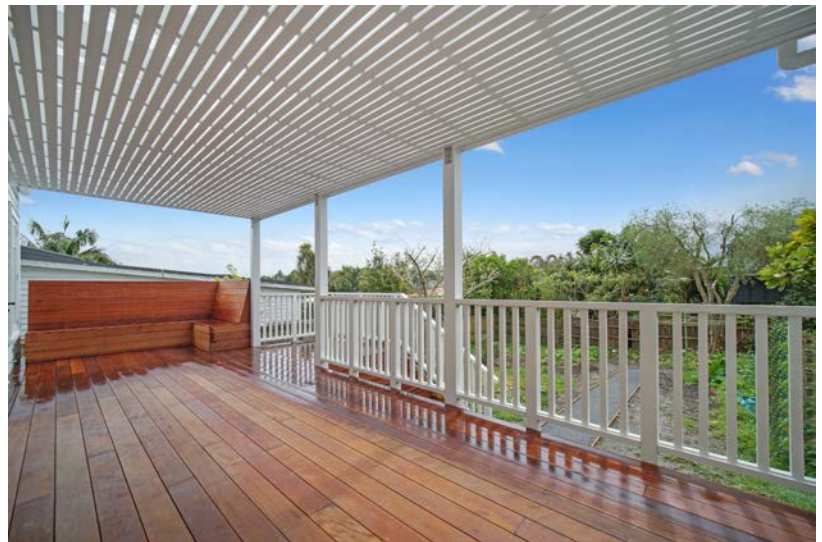
I was also in charge of building the balustrade. The first task was to mark out the posts between the pergola posts and bolting them to the deck framing. Following the MiTek face fixed baluster posts detail, the 88x88mm H5 laminated post could not be spaced greater than 1m centres. I determined that the baluster centres would become 118mm (76mm gaps) between the pergola posts. However, I ensured the same centres could work around the landing area and down the stairs. With the posts spaced two baluster centres further apart but no further than 1m, the entire balustrade would be the same. I also found an easier and faster way of creating the balustrade. We would make a premade panel by pinning and screwing a 10x42mm fillet to hold the 42x42mm H3.2 balusters at the correct centres between the structural posts. They could then be screwed to the bottom rail with the capping and then placed on top, which were both 88x42mm H3.1. This saved time compared to the nailing three jolt headnails per end of each baluster.
