# Thomas O'Brien      *Apprentice of the year 2020 project submission*

## Project intro: 15A Kawerau Avenue, Devonport

The Kawerau ave job is a 1960's brick and tile attached unit that we renovated. The roof was rebuilt to allow for raking ceilings and long-run iron roof cladding. The interior floor plan was completely changed and an extension for the front entryway was added with a new carport supported off it. The renovation involved a wide range of skills from foundation works to finishing to complete the project. The site was the rear section approximately 50m back from the road with fencing on either side and the driveway was to remain so no heavy vehicles were allowed up it. Following the excavation a scaffold was erected around the building then a shrinkwrap tent was erected over it so that work could continue in all weather. Various Trades were needed due to the large scope of works involved in the renovation and Timberworld was our go-to supplier due to their wide range of stock and helpful customer service. On this job I worked closely with the foreman John to help grow my skills as he has been in the building trade for 40 plus years and a very willing teacher. I was al

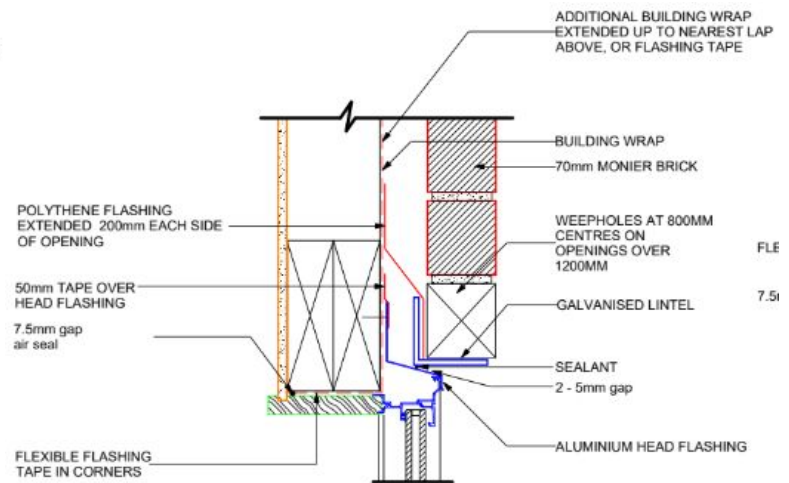
### 23/10 WEATHERBOARD/MASONRY VENEER JUNCTION INTERNAL CORNER

- Note:
- For openings greater than 2.0m, provide a landing for the lintel of 200mm for each side of the opening.
  - For openings less than 2.0m allow 100mm each side of opening.

- Important:
- All lintel bars must be propped until mortar is set (7 days).
  - It is important to allow the first 3 courses of the brickwork over an opening to set before laying any more bricks above. Provide brick ties within the bottom two courses.
