# TANZ

TILE ASSOCIATION  
OF  
NEW ZEALAND

# Planning for success starts with design

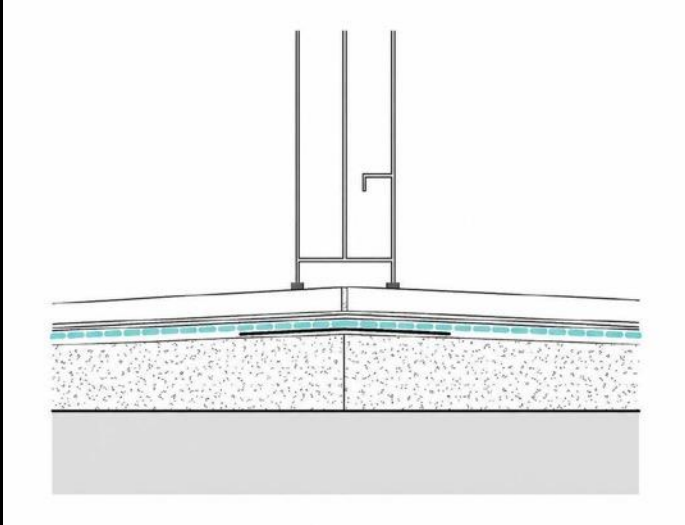
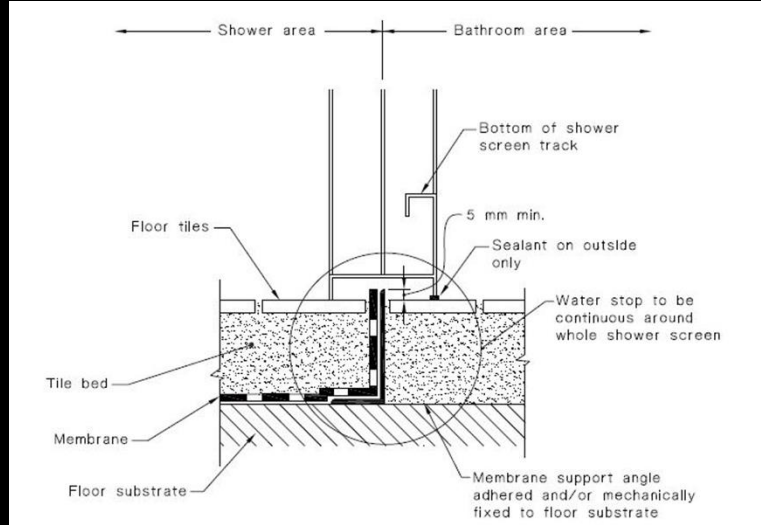
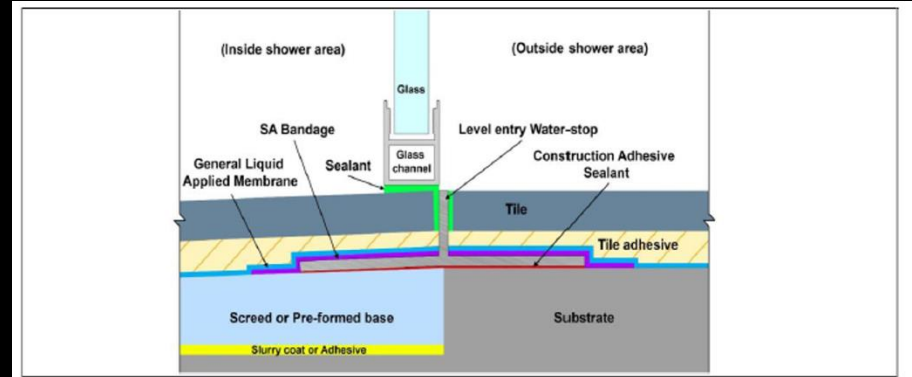
**Figure 26 Typical Level Entry Shower**

1. Where a screed or pre-formed base is not used to form falls, falls must be formed in the installation of the substrate itself, e.g., lay sheet substrates on firrings.
2. Grout lines must be positioned over directional changes in the waterproofing membrane system.

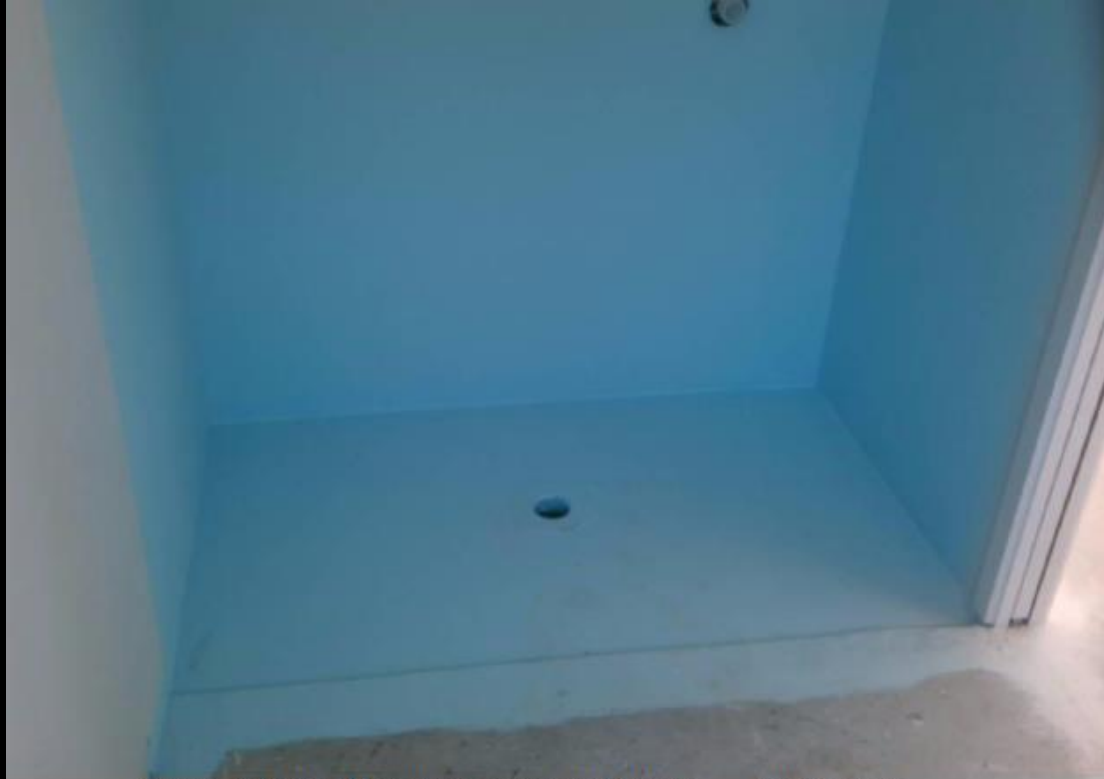
Taken at 10:48 AM on Wednesday 27/04/2016 Status: Pass
